**Bulletin No:** P-064-16

**Subject:** Induction Cleaning on *All* Lexus IS Model Vehicles

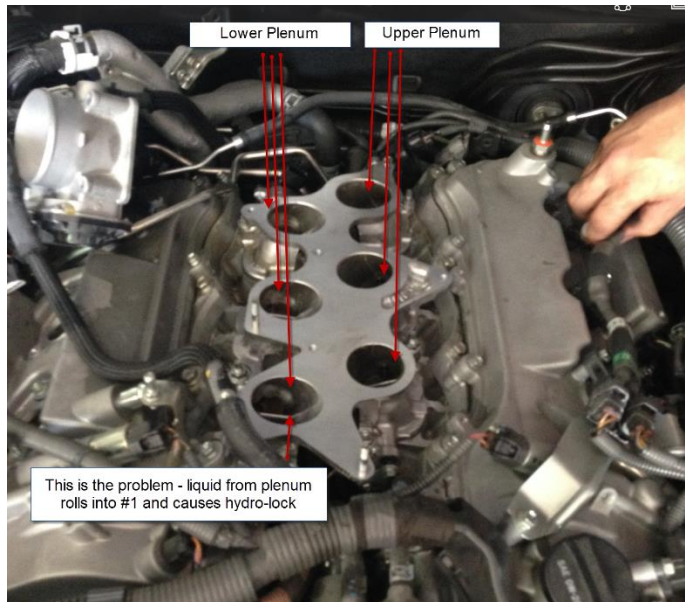
The intake manifold is a dual plane design. The upper portion feeds the right engine bank and the lower feeds the left. The throttle body has a long sweeping curve that is 12" from the plenum, and then is open to the lower and upper plane of the manifold. There are 4 possible locations to introduce an Induction Cleaner:

1. An auxiliary vacuum source (capped not used) at the front behind throttle body
2. Cold start injector (across the plenum from cylinders)
3. Brake booster
4. Throttle Body

As a result of the significant distance from each vacuum source and throttle body to the plenum, the atomized product reverts to liquid and collects as a liquid in the bottom of the plenum. The collected liquid from the plenum may enter cylinder #1 causing catastrophic engine damage.

**We do not recommend any form of Induction Cleaning on these vehicles (ALL model years) for the following reasons:**
